GEOLOGIC FAULT HAZARD SUMMARY

Sonoma County – Chanate Campus

3325 Chanate Drive
Santa Rosa, CA

ZFA Project: 14565.03

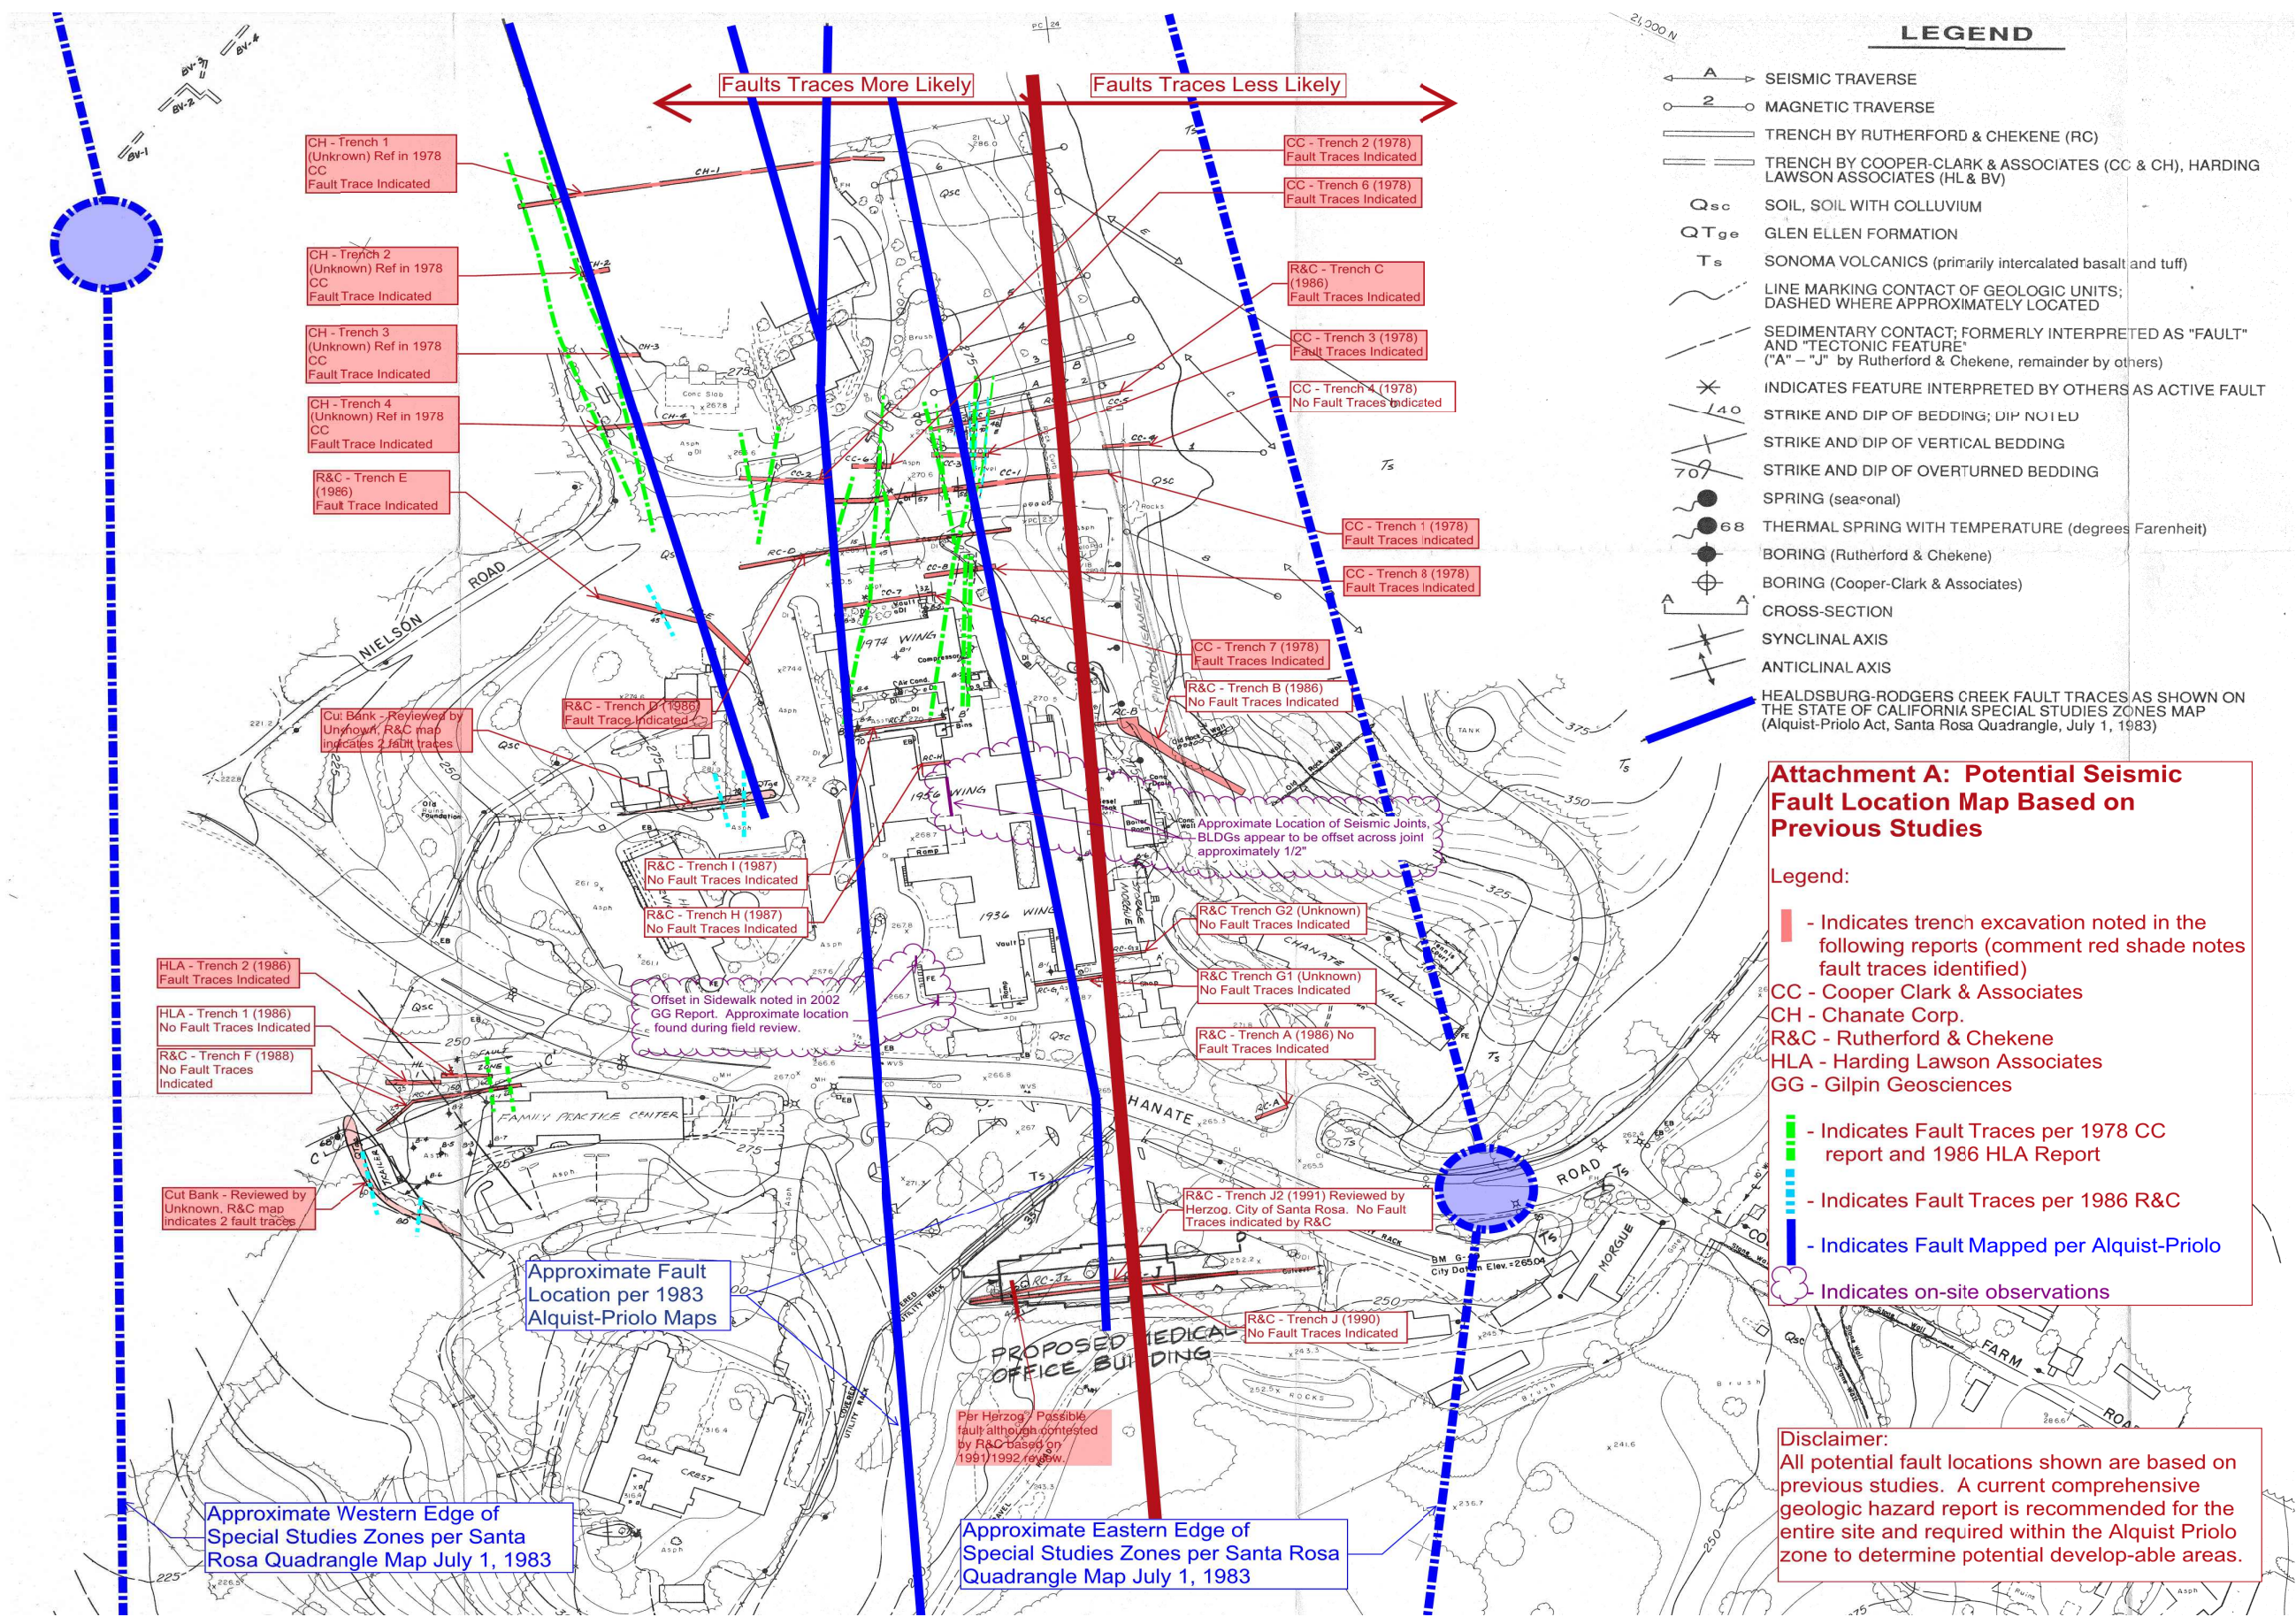
Multiple Geologic Hazard Evaluations and Geotechnical Reports have been performed for various areas of the site. Additional information may be obtained from California Department of Conservation – California Geological Survey (CGS). The exact fault locations at the site and in the AP zone are not clearly determined by the reports due to differing data and conclusions as evolved over time. Some reports stated that ruptures may occur at many places within the weak upper materials in the wide fault zone rather than along a few well defined narrow traces. Some reports note that some faults were not active because they didn't project through bedrock material that was less than 11,000 years old. See Attachment A: Potential Seismic Fault Location Map Based on Historical Studies for compiled mapped potential fault locations as reviewed.

Geologic Hazard Evaluations and Geotechnical Reports were provided and reviewed¹ for the "Seismic Evaluation of the Chanate Hospital Buildings" performed by ZFA for the County of Sonoma and finalized in February 2015. Based on the information contained in the reviewed geotechnical reports and the CDMG maps, the intersection of the Rodgers Creek Fault, to the south, and the Healdsburg Fault, to the north, is projected to occur in the area of the Chanate Campus site. While both faults are clearly defined and located outside of the Santa Rosa area on AP maps, the fault location at the campus site is inferred.

Four of the five geotechnical engineers that provided information for the site concluded there were likely fault traces or fault related features extending through at least some portion of the site. The reviewed

documents indicate that surface fault rupture and surface displacement at the site are potentially anticipated; however, this displacement may occur across a complex series of faults. There appears to be areas of the site where fault traces may be less likely to occur based on the fault locations provided.
